1
FOR OFFICIAL USE ONLY
B.S.
AD _____
RDT&E PROJECT NO. _____
USAATECOM PROJECT NO. 4-6-0251-05
6
COMPARATIVE TEST
of
THE OH-6A ENGINE INLET FILTER
AND PARTICLE SEPARATOR.

9 Final Report of Test
by
10 Major Charles L. Raymond
Mr. Richard J. Followill
11 1 April 1968

DEPARTMENT OF THE ARMY
UNITED STATES ARMY AVIATION TEST BOARD
Fort Rucker, Alabama 36360

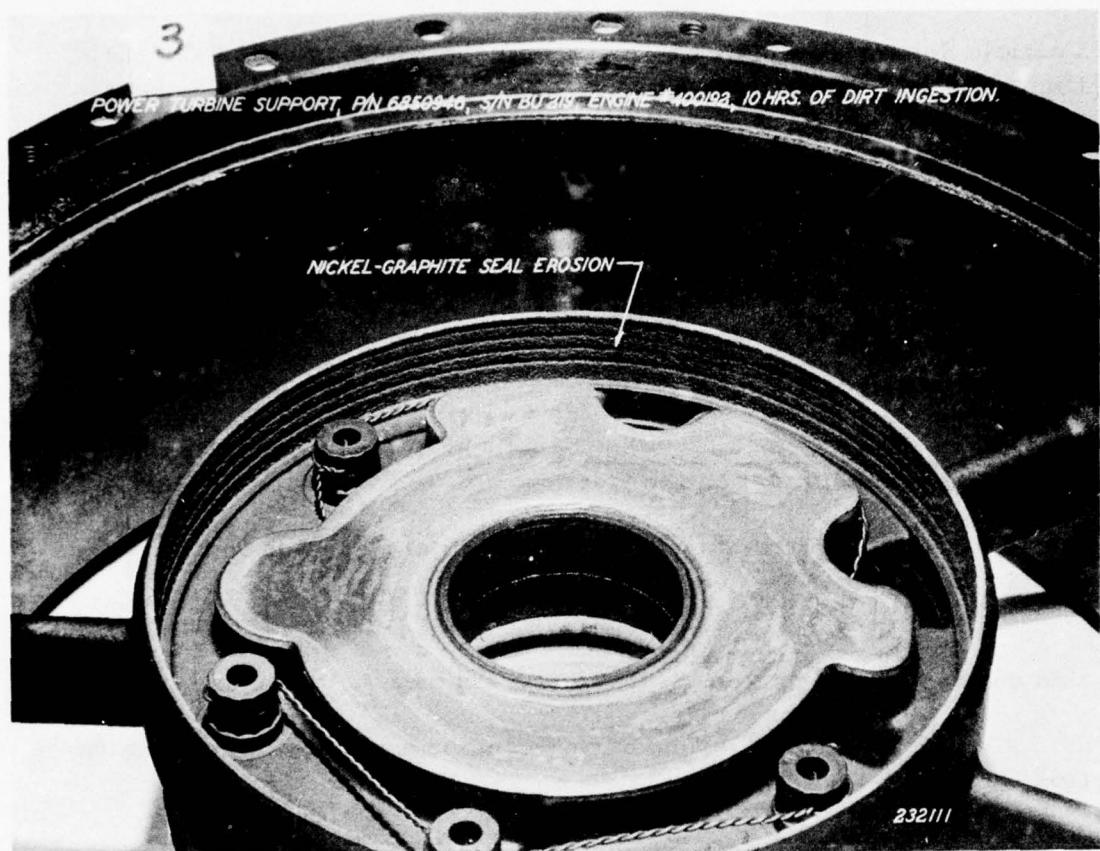
Figure 19

(2) The 10-hour Particle Separator engine showed slight visual erosion in the circumference of the seal (figure 19). The average change in radial clearance owing to erosion of seal material was 0.0016 inch (figure 16, appendix I, section 3).

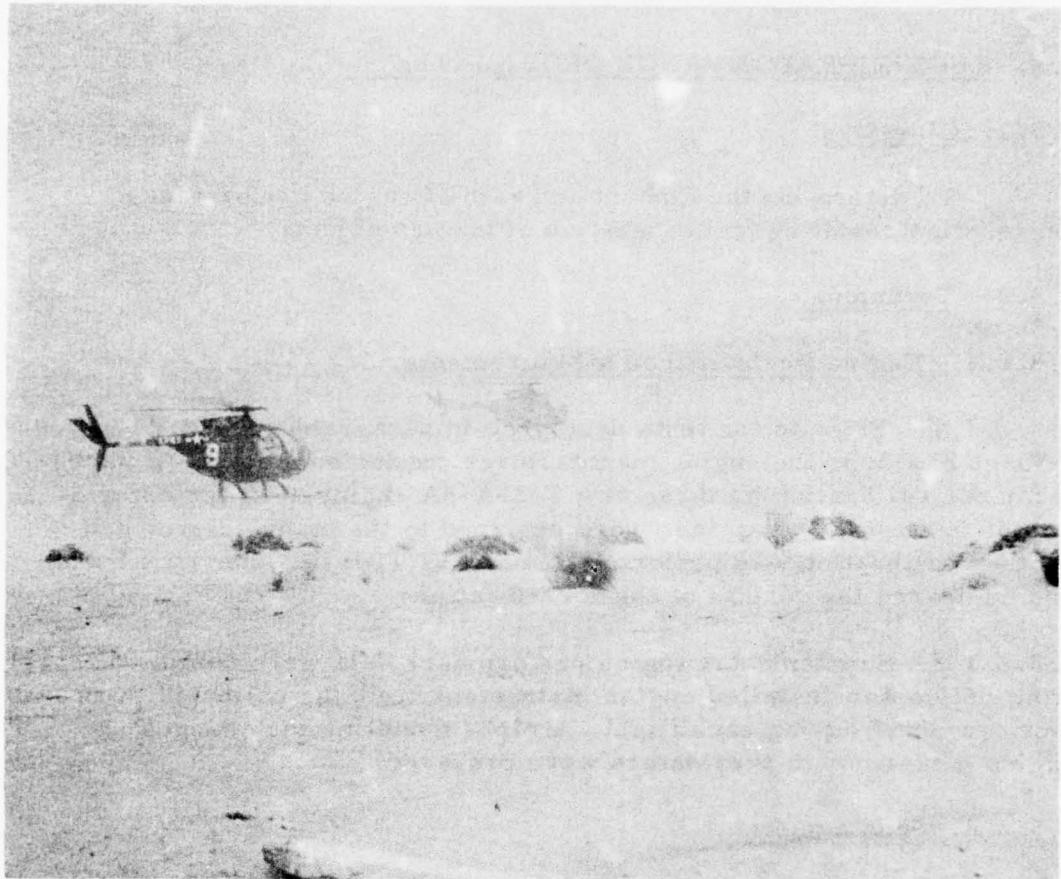
Figure 23. The OH-6A Helicopters, with protective systems installed, hovering over sand surface.

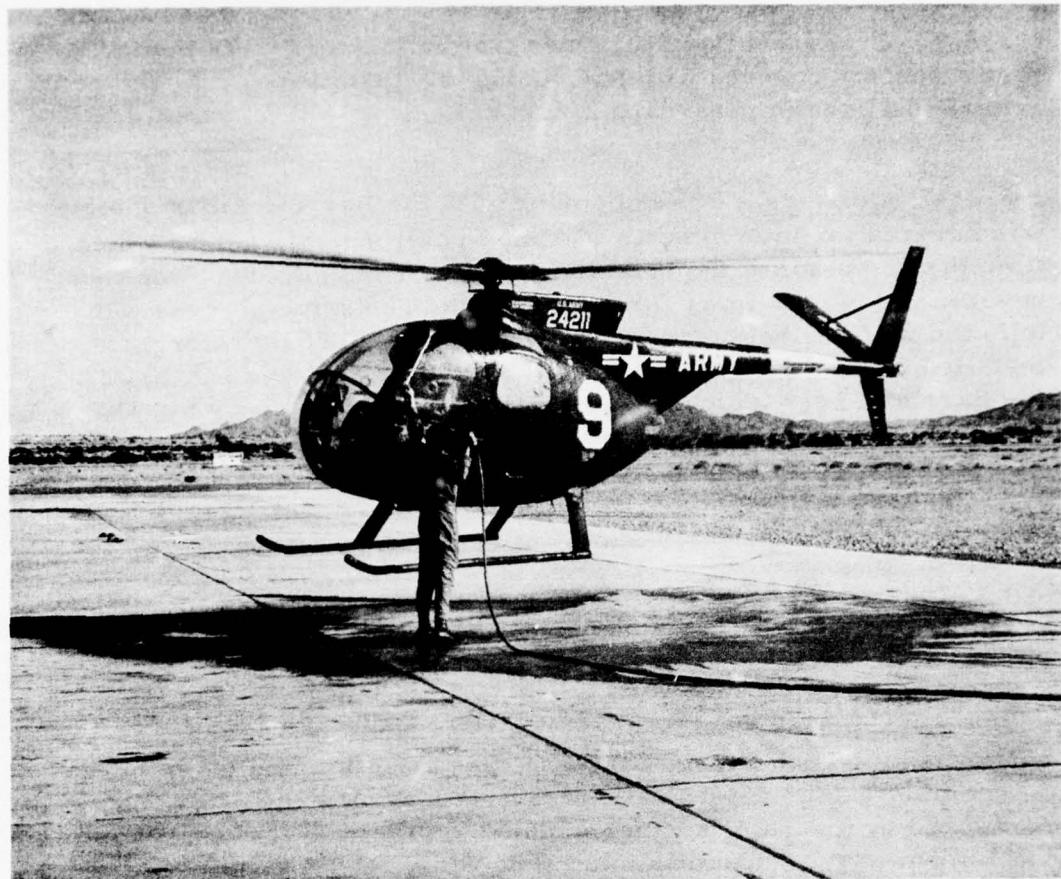
Figure 24. The OH-6A, with protective system installed, hovering in water spray.

2.3.2.4. Moisture. The helicopter with the Barrier Filter installed was hovered for four minutes in a dust environment, during which time the Δp reached the maximum limit. The helicopter was then hovered in a water spray for 10 minutes. The same process was followed with the helicopter on which the Particle Separator was installed (engine S/N 400191). With a clean filter element installed, the Barrier Filter helicopter was hovered in water spray for 10 minutes and then hovered in dry air until the Δp stabilized. Again, this procedure was duplicated by the Particle Separator helicopter in order to keep the engine environmental exposure equal. (See figure 24.)
